Re: Application for Industrial Sewage Works Certificate of Approval
East End Environmental Protection System
Hornepayne Yard, Hornepayne, Ontario

From: KGS Document Control [sallison@kgsgroup.com] (CN)
Sent: November 27, 2013 10:04 AM
To: Crosson, Kirk (ENE); ntropea@kgsgroup.com; sallison@kgsgroup.com
Subject: Tropea_IR_CN Hornepayne 2013 Environmental Services_KGS_13-0434-004-00005

**LOCAL PERSONNEL
WEEKLY ENVIRONMENTAL PROTECTION SYSTEM INSPECTION
HORNEPAYNE YARD, HORNEPAYNE, ONTARIO**

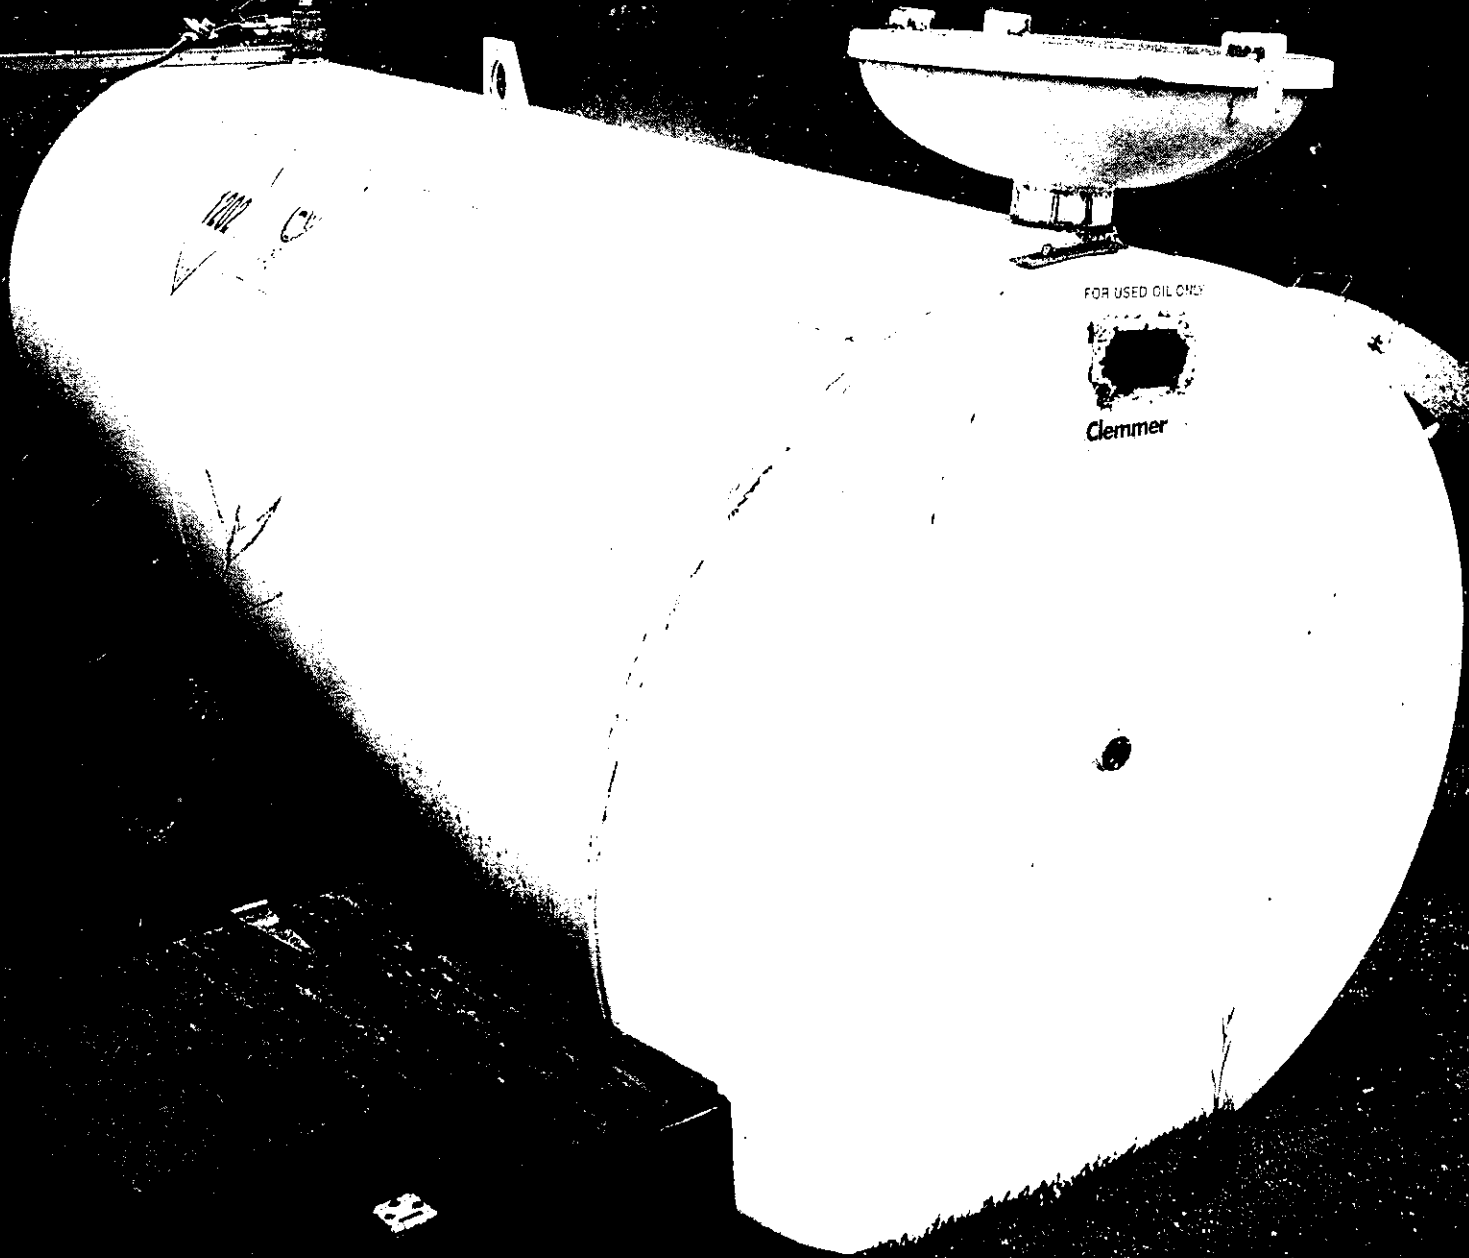
FOR USED OIL ONLY
